In 2012, the Thomas Jefferson Planning District Commission (TJPDC), also known as Region 10, started an initiative to study, promote and improve its portion of U.S. Bicycling Route 76 (BR 76). This report is the first step in this initiative, creating an inventory of existing conditions and highlighting recommendations for improving the safety and recreational value of the Route.

This report is a technical document, intended to highlight roadway deficiencies that diminish cycling safety along BR 76, in Region 10. As a technical document, the intended audience includes regional and state transportation planners, along with cycling advocates. This report is intended to document cycling compatibility, with a secondary goal of recording cycling amenities and tourist destinations.

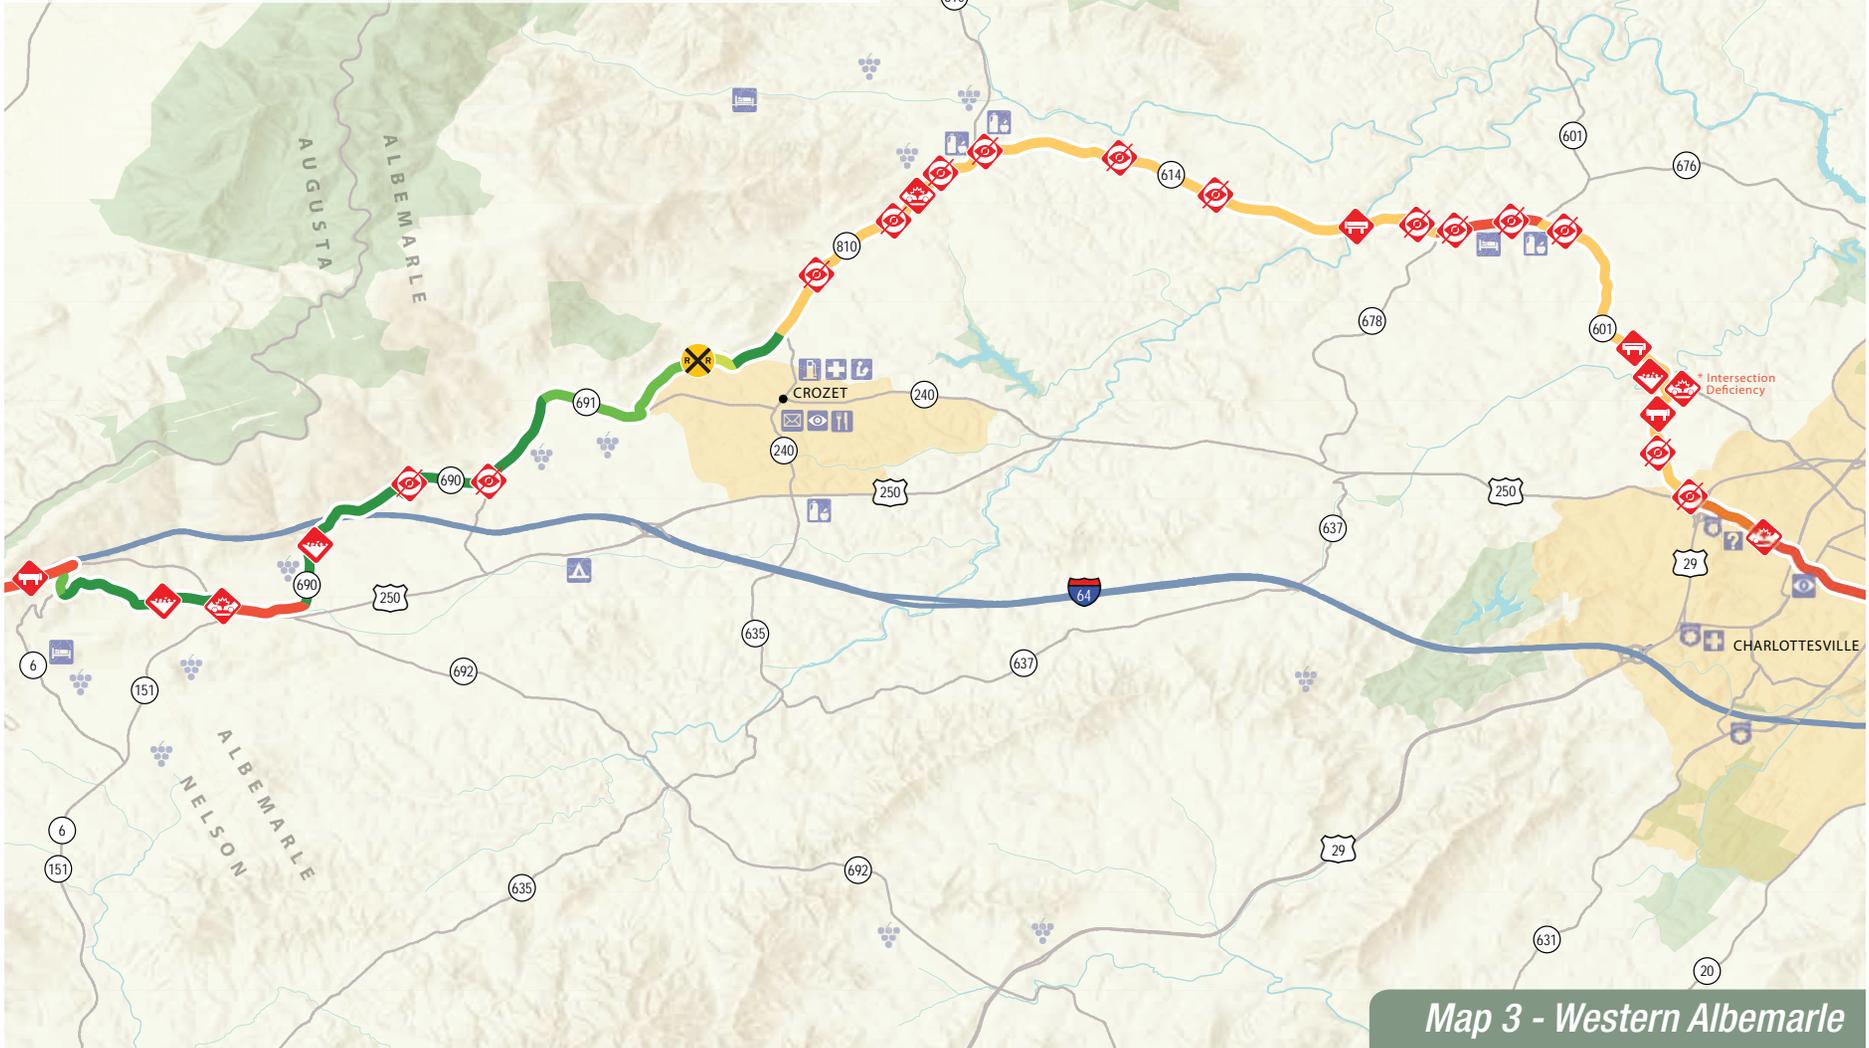
Map 3 - Western Albemarle

The western side of Albemarle County is home to some of the most valued scenic vistas on BR 76, along with several tourist destinations. In terms of safety, the over 26 miles of BR 76 also presents frequent cycling hazards. Map 3 illustrates the various safety deficiencies, involving sight-distances, uneven road surfaces, dangerous intersections and guardrails.

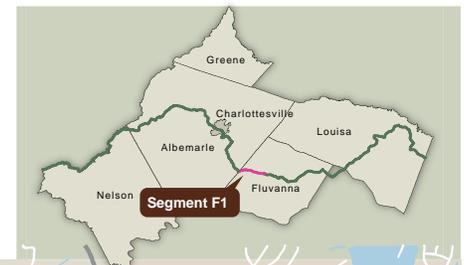
C Bike Level of Service	600 Annual Average Daily Trips	45 Posted Speed (MPH)
9' Average Lane Widths (feet)	0' Shoulder/Bike Lane Width (feet)	0% Truck Traffic (percent)
Positive Contributing Factor		Negative Contributing Factor

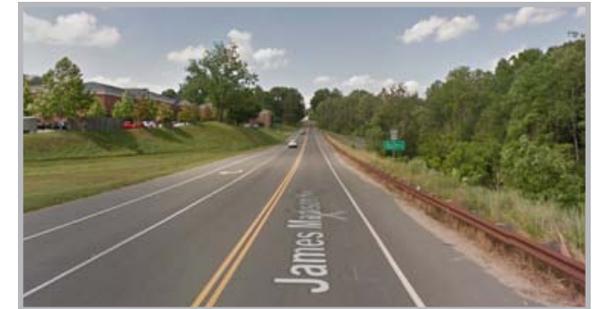
Figure 18-2: Road Section with Wide Shoulder

There are several locations where the road section includes guardrails. These hazards are minimal on US 53, because of a wide grass shoulder. On US 15, the wide paved shoulder narrows between the County Office Building and Courthouse Road. In that area, there is a 200-foot long guardrail on the northbound lane, with no shoulder. Since this guardrail is on the uphill side of the road, it is particularly hazardous because cyclists travel at slower speeds and require additional space to maneuver. (Figure 18-5)

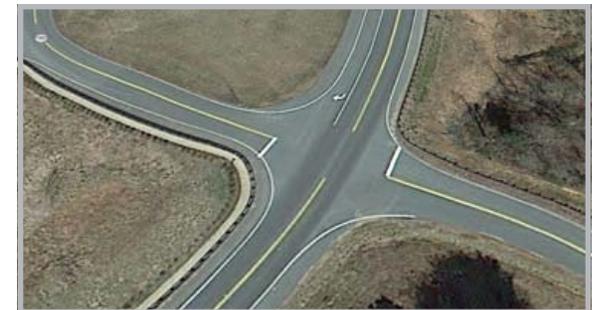
Figure 18-3: Main Street/Stoneleigh Road

VDOT recommends that this four-way intersection be designed as a roundabout. The main issue with the intersection is the volume of traffic, which is relatively high. (Figure 18-3)

about. The preliminary engineering is completed. The project is a local priority, per the RLRP. The Fluvanna County Comprehensive Plan also recommends a new roundabout or signalized intersection at South Main Street.

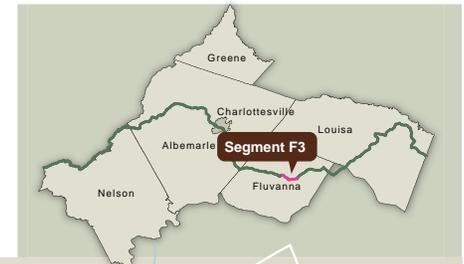
C Bike Level of Service	980 Annual Average Daily Trips	40 Posted Speed (MPH)
9' Average Lane Widths (feet)	0' Shoulder/Bike Lane Width (feet)	0% Truck Traffic (percent)

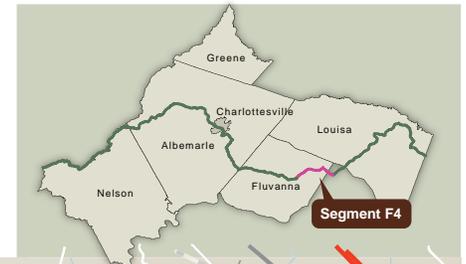
B-C Bike Level of Service	385 Annual Average Daily Trips	55 Posted Speed (MPH)
9' Average Lane Widths (feet)	0' Shoulder/Bike Lane Width (feet)	0% Truck Traffic (percent)
Positive Contributing Factor		Negative Contributing Factor

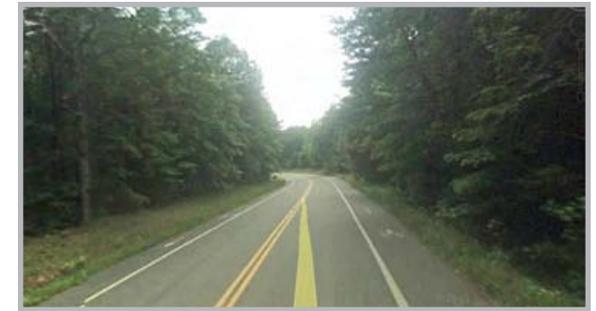
Figure 20-2: Bike Lanes

There are three (3) locations with guardrails in this corridor, but only one location presents hazards to cyclists. At the other locations, the addition of bike lanes provides space for cyclists. At the Phils Creel culvert, there is 1,650 feet of bike lanes, in each travel lane. At the Kent Branch culvert, there is 850 feet of bike lanes. (Figure 20-3)
