In 2012, the Thomas Jefferson Planning District Commission (TJPDC), also known as Region 10, started an initiative to study, promote and improve its portion of U.S. Bicycling Route 76 (BR 76). This report is the first step in this initiative, creating an inventory of existing conditions and highlighting recommendations for improving the safety and recreational value of the Route.

This report is a technical document, intended to highlight roadway deficiencies that diminish cycling safety along BR 76, in Region 10. As a technical document, the intended audience includes regional and state transportation planners, along with cycling advocates. This report is intended to document cycling compatibility, with a secondary goal of recording cycling amenities and tourist destinations.

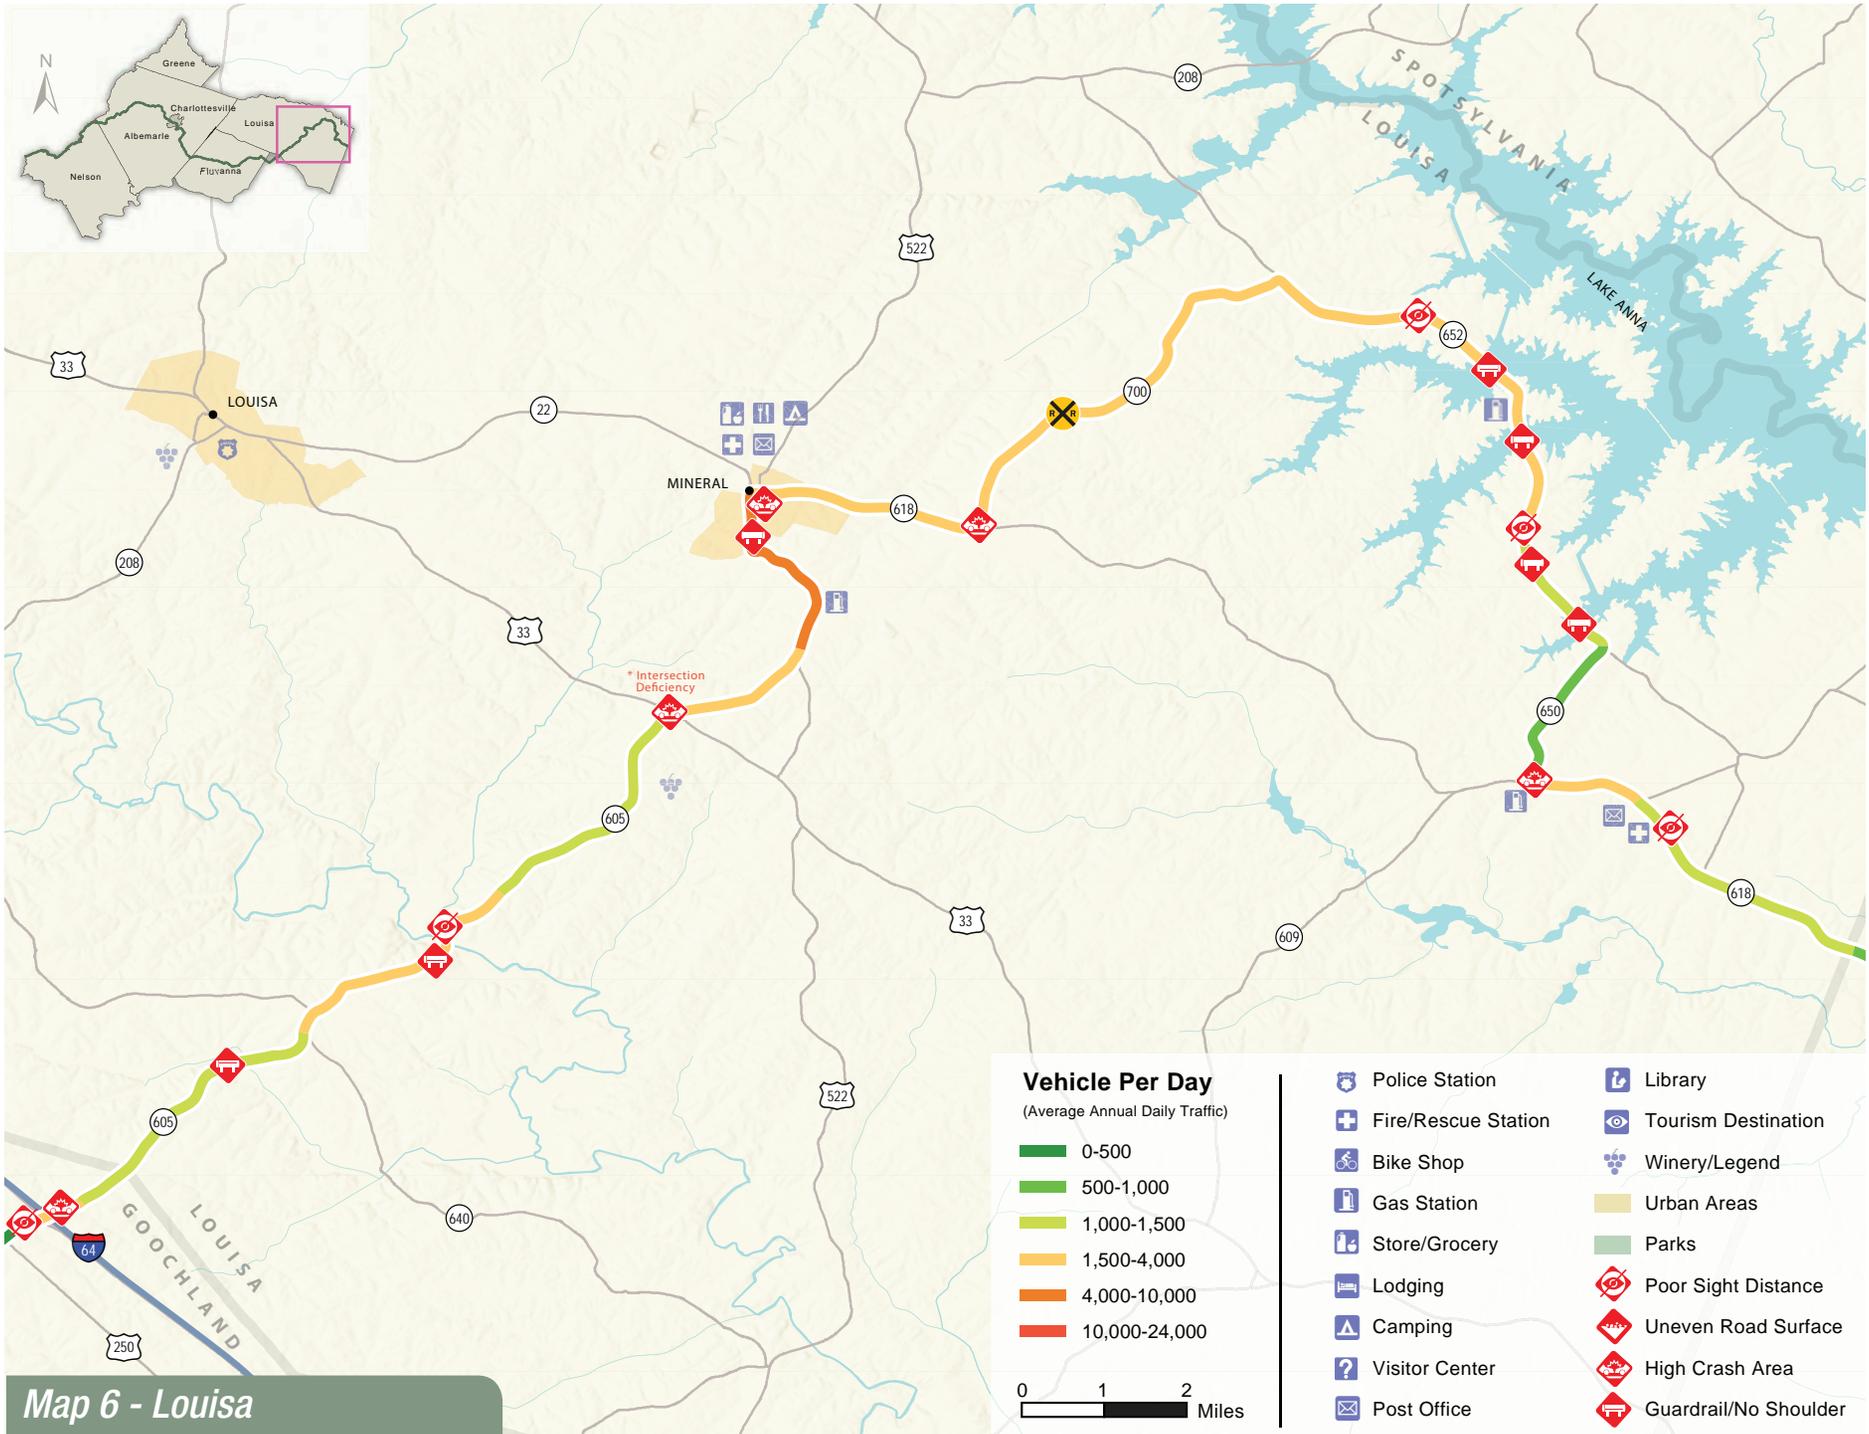
Map 6 - Louisa

There are nearly 35 miles of BR 76 in Louisa County, passing through the only incorporated town along the study area. In Louisa County, the most common road hazards are narrow roadways with guardrails. Refer to Map 6.

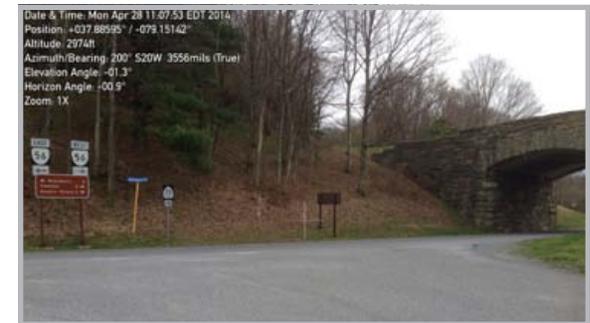
Figure 1-2: Crabtree Falls Intersection

This is a grade-separated rural interchange, marking the southwestern end of this corridor. With low traffic volumes and sufficient sight distances, there are no immediate deficiencies apparent in this area. (Figure 1-2)

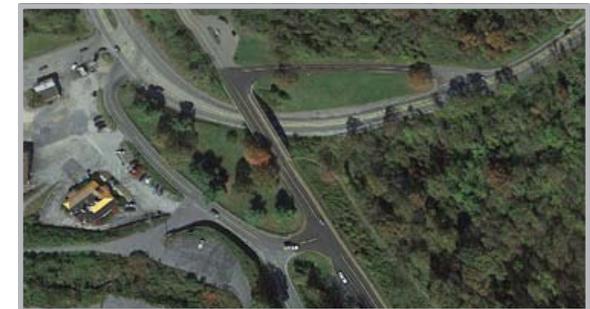
Figure 1-3: Sight-Lines at US 250

There are obstructed views looking east, due to an embankment adjacent to the west-bound lane. This visual obstacle allows for less than 250 feet of sight distance. If traffic on US 250 is moving at 45 MPH, then a cyclist would have less than 4 seconds to complete a left turn onto US 250 before an approaching vehicle reached the intersection. There are also obstructed views to the west, due to vegetation on the northwest corner of the intersection ramp. This obstruction allows for less than 200 feet of sight distance, looking west from the ramp. That sight-line gives cyclists 3 seconds to complete a left turn from the ramp. (Figure 1-3)

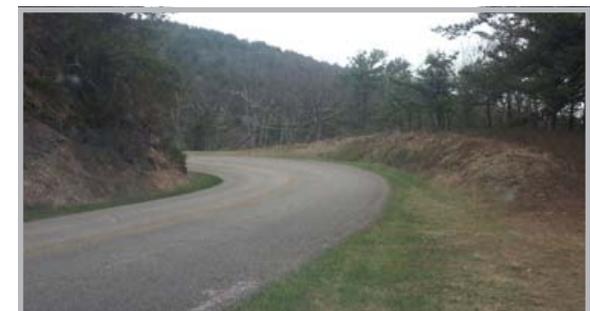
Figure 1-4: Problematic Sight-Lines

There are select curves with poor horizontal sight distance. These hazards are more problematic to cyclists when motorists have blocked sight-lines of the uphill lane. As cyclists climb, they travel at lower speeds and typically require additional room to maneuver. (Figure 1-4)

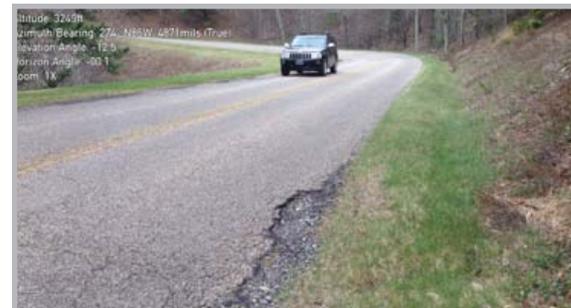
Figure 1-5: Poor Surface Conditions

The is repaving the Parkway road surface to address wear and tear of the existing pavement. (Figure 1-5)

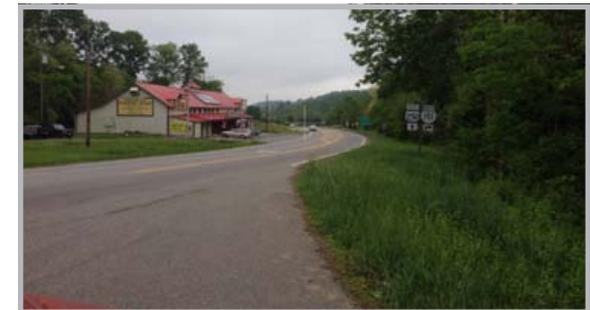
Figure 4-3: US 151 Intersection, Looking West

The T-Intersection with US 151 is a major area of study for VDOT. Due to high traffic volumes, the existing intersection configuration experiences periods of long traffic queues, as vehicles attempt to turn onto other legs of the intersection. In terms of crashes, there were 26 recorded accidents, between 2005 and 2011. Most of these crashes were directly related to the intersection. (Figure 4-3)

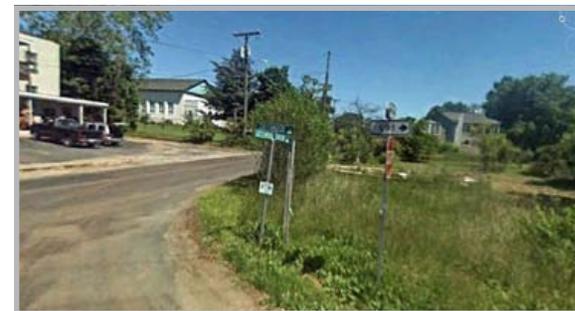
Figure 5-2: Sight Distance on VA 691

There are geometric deficiencies at the Greenwood Road intersection. From VA 691 (Greenwood Road – South) vegetation obstructs sight-lines to the east, on Greenwood Station Road. There is also potential for access management issues, as three (3) properties have ingress/egress within the intersection. These properties include an antique store, single-family home and the post office. While this can create additional conflict points within the intersection, these are low-volume access points. (Figure 5-2)

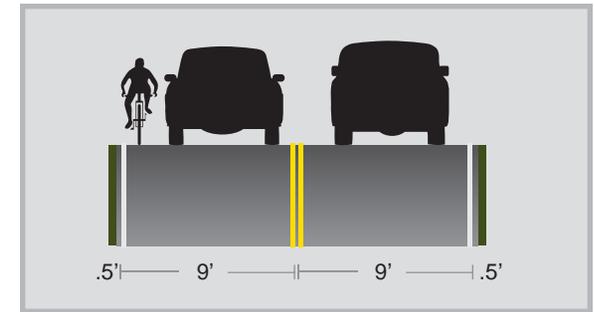
Figure 9-1: Typical Road Section

There are multiple cycling hazards on Garth Road, but the most notable is the lack of shoulders. Along the roadside, there are few places for a cyclist to bail from the travel lane, in cause of emergency. The roadsides are commonly

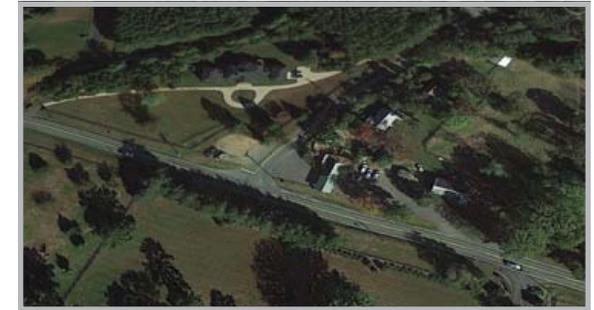
Figure 9-2: Free Union Road Intersection

Between 2005 and 2011, there were ten (10) recorded crashes at this T-intersection. A country store on the northeast corner introduces additional turning movements and conflict points. An embankment in front of the store also creates obstructions to sight-lines. There should be additional study of this intersection to identify deficiencies. (Figure 9-2)

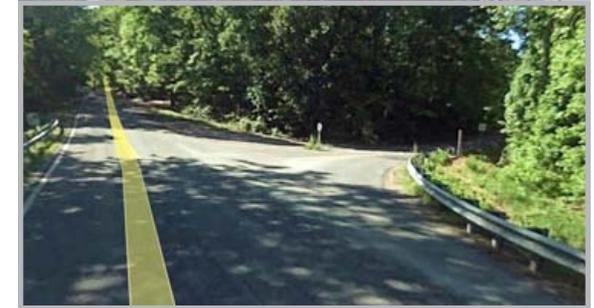
Figure 9-3: Old Garth Road Intersection

Local cyclists expressed concern about this T-Intersection with Old Garth Road. The intersection lies at the bottom of a ravine, which creates higher travel speeds as vehicles gather momentum on the downhill lanes. This may be a contributing factor to the seven (7) vehicular crashes that occurred within this intersection, between 2005 and 2011. *Note: there were no reported crashes that involved cyclists.* (Figure 9-3)

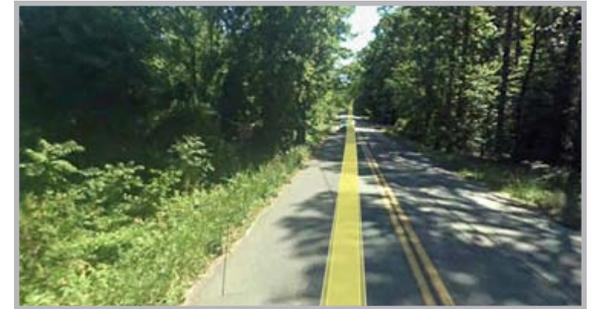
Figure 9-4: Roadside Vegetation

flanked by ditches, small embankments or trees that stand close to the road's edge. (Figure 9-4)

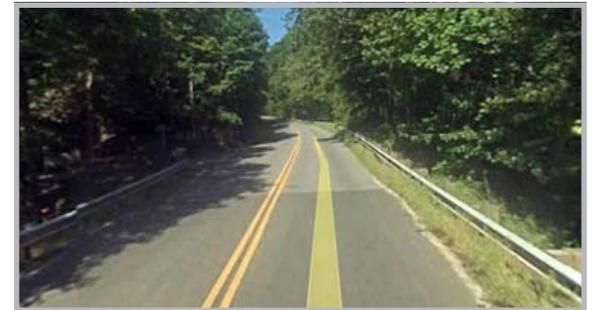
Figure 9-5: Guardrails on Uphill Lane

There are also locations with guardrails, which limit the ability of cyclists to maneuver away from the road. These conditions are particularly hazardous on climbs. (Figure 9-5)

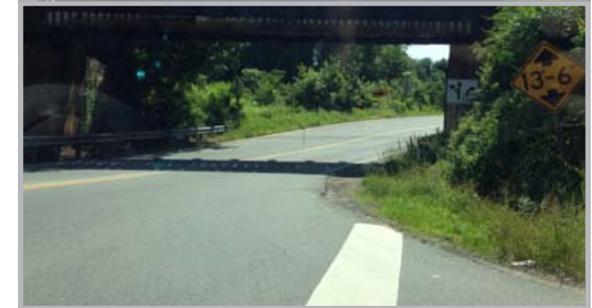
Figure 10-3: Sight-Distances at VA 846

This is potentially one of the more dangerous intersections in the study area, with high traffic volumes and travel speeds. Additionally, there are major deficiencies with sight distances. From the western leg of Old Garth Road (eastbound), the railroad bridge and embankment to the south blocks views of oncoming traffic. (Figure 10-3)

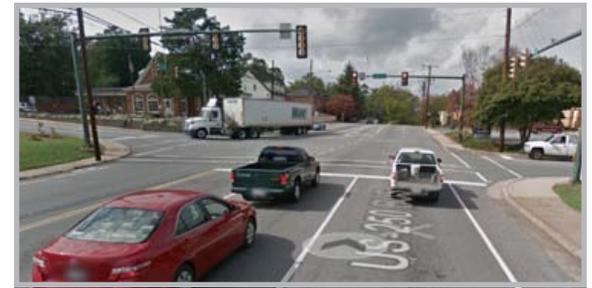
Figure 11-1: Typical Road Section

and Rothery Road, the street section includes five (5)-foot bike lanes that are clearly marked. (Figure 11-1)

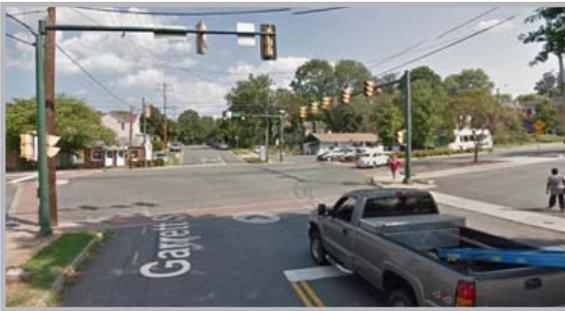
Figure 12-5: Avon Street

The intersection at Garrett and Avon creates challenges for cyclists. With 5 legs, there are additional turning movements and potential conflict points between vehicles and bicycles. On Avon Street, cyclists must cut across travel lanes in order to make a left turn onto Garrett Street, crossing paths with motorists. (Figure 12-5)

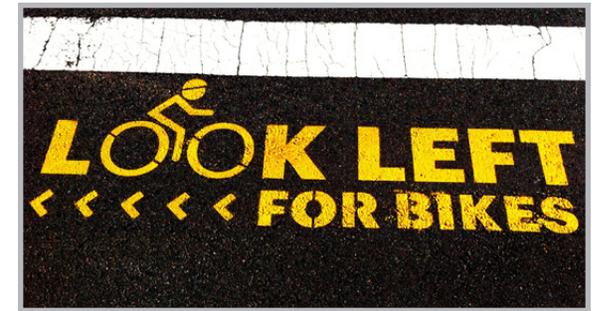
Figure 12-6: Road Stencil

There should also be discussions of road stencils at crosswalks, warning pedestrians of cyclists. (Figure 12-6)

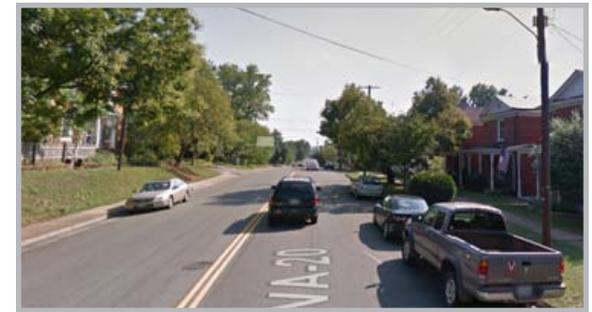
Figure 13-1: Typical Road Section

The street section varies, as the roadway transitions to the wider widths on Scottville Road or as turn lanes appear and taper away. Overall, the roadway is typically 44 feet wide on Monticello Avenue and Avon Street. The travel lanes are approximately 12 feet wide, with an additional eight (8) feet on the outside edge for on-street parking. None of the on-street parking spaces are marked. Adjacent to the road pavement, there is curb and gutter, along with 5-foot sidewalks. On Avon, the City recently created bike lanes, narrowing the travel lanes but creating a much improved cycling environment. (Figure 13-1)

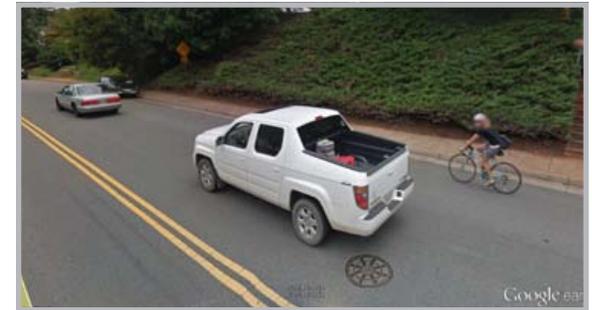
Figure 13-2: Typical Road Section - Uphill

On the uphill route, the roadway ranges in width, from 20 to 25 feet. There is sporadic on-street parking on these streets, along with crosswalks and sidewalks. (Figure 13-2)

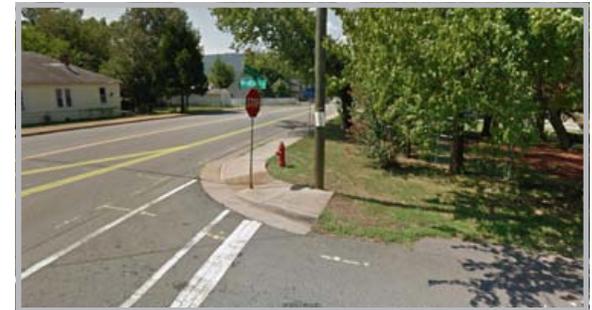
Figure 13-3: Sight-Lines at Cross Streets

most intersections are evenly spaced. Most intersections have 4 legs, which includes lower volume cross streets. There are instances of poor sight-lines at these intersections. (Figure 13-3)

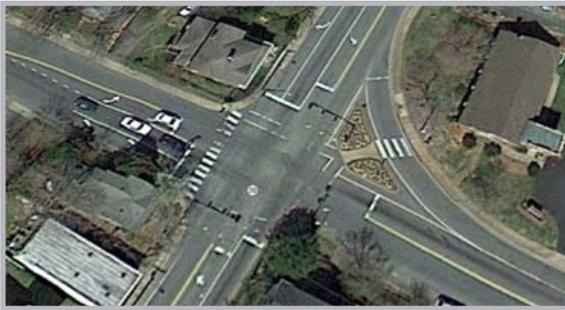
Figure 13-4: Avon Street/Monticello Avenue Concept

The City of Charlottesville is studying this intersection and exploring several innovative approaches to improving cycling safety. Westbound, on Monticello Avenue, cyclists must take a channelized right turn onto Avon Street. With this movement, cyclists merge into the same lane as motorists, who are turning left on Avon Street from the western leg of Monticello Avenue. For bikes traveling southbound on Avon Street, cyclists must turn left onto Monticello Avenue, crossing multiple lanes. (Figure 13-4)

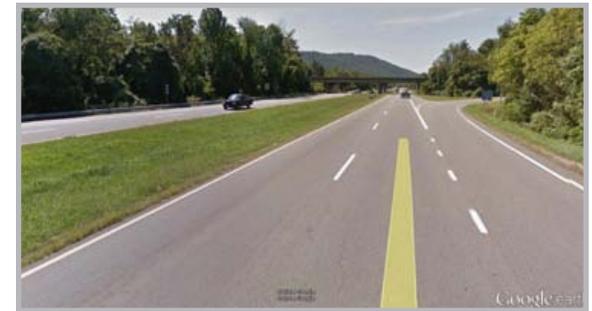
Figure 14-1: Typical Road Section

Scottsville Road is the only four-lane road in the study area (excluding turn lanes). Each travel lane is 12 feet. Separating the north- and southbound lanes, there is a grass median that is 40 feet wide. On the outside lanes, the shoulders vary greatly throughout this corridor. There are no paved shoulders on the southern section, with a guardrail that is directly adjacent to the road pavement. Near the intersection with College Drive, the shoulders widen to 12 feet, though the surface is gravel. The widest shoulders are near the Interstate 64 interchange, where there are 12-foot, paved shoulders. There are no shoulders in the remaining sections of the corridor. (Figure 14-1)

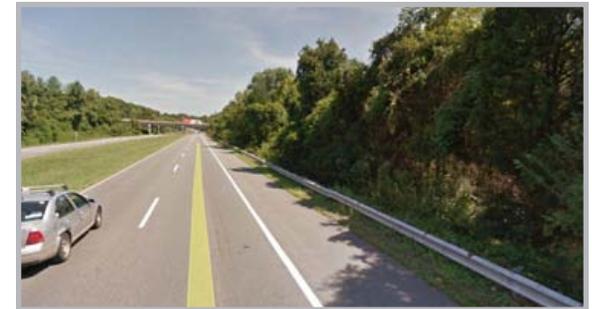
Figure 14-2: Typical Section with Wide Shoulder

The bike facilities vary in this corridor. Along some segments, cyclists share the same travel lanes as motorists. In other locations, cyclists can use of paved shoulders on the outside lanes. (Figure 14-2)

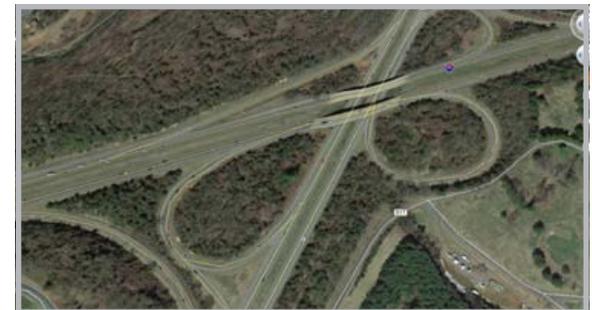
Figure 14-3: I-64 Interchange

numerous hazards to cyclists. There is a high volume and speed of traffic that must weave on/off the ramps. These traffic movements introduce conflict points, where vehicles cross paths with cyclists. (Figure 14-3)

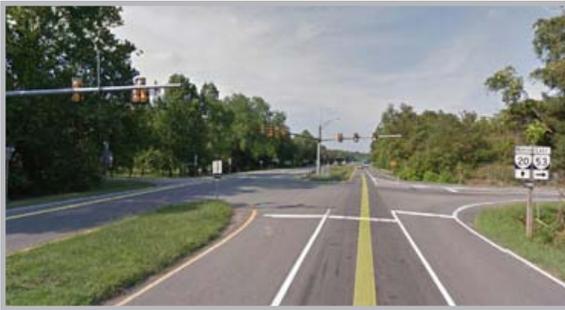
Figure 14-4: US 20/53 Intersection

The T-intersection at US 53 is one of the more dangerous intersections for cyclists in the study area. While sight distances and access management are adequate, there are high volumes of traffic that travel through this intersection on a daily basis. On US 20, there are multiple lanes of traffic, with vehicles traveling at high speeds. The signalization helps to improve safety for cyclists, but the paths of vehicles and bicycles overlap at multiple points. Note: There were recent improvements to this intersection, including installation of a channelized turn. These improvements will help to improve cycling and overall road safety. (Figure 14-4)

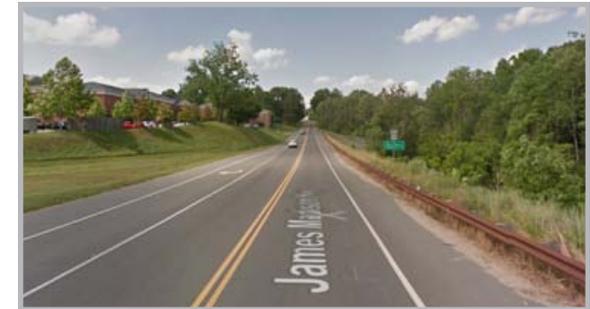
On US 15, there are seven (7) to ten (10)-foot paved shoulders, except for the section between the County Office Building and Courthouse Road, where there is no shoulder. (Figure 18-2)

Figure 18-2: Road Section with Wide Shoulder

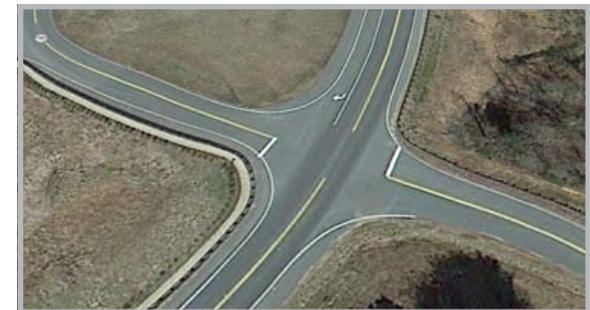
VDOT recommends that this four-way intersection be designed as a roundabout. The main issue with the intersection is the volume of traffic, which is relatively high. (Figure 18-3)

Figure 18-3: Main Street/Stoneleigh Road

» *Intersection Improvements*

Improvements to the VA 53/US 15 intersection are listed in the Comprehensive Plan, RLRP and SYIP. In the SYIP, the project includes the addition of a rural, single lane round-

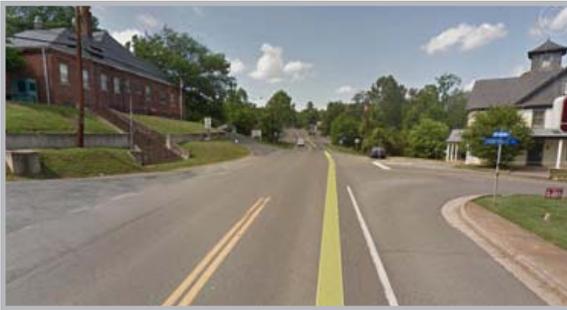
Courthouse Road forms a T-intersection with US 15, though there are additional legs that are close to this intersection. Those additional legs include Church Street, Palmyra Way and Court Square. With these additional legs and entrances, there is potential for conflict points, where motorists and cyclists could cross paths. Five (5) crashes that occurred at this intersection, between 2005 and 2011, though none involved cyclists. (Figure 18-4)

Figure 18-4: Courthouse Road Intersection

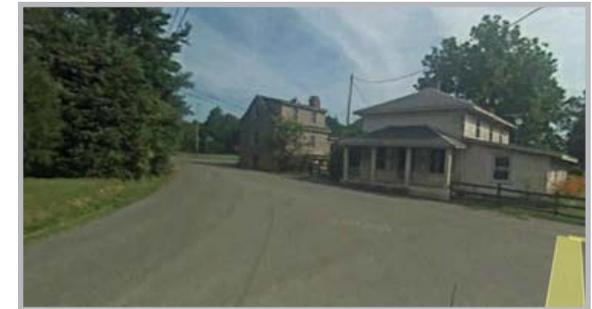
At the intersection with Wilmington Road, VA 601 essentially creates two (2) T-intersections. Between those intersections, there are two (2) structures that are directly adjacent to the roadway. The home at the corner abuts the road, obstructing sight-lines. There is also a driveway behind this corner lot, creating additional conflict points near the intersection. Despite these concerns, there are relatively few accidents in this area, with 3 recorded crashes. (Figure 19-2)

Figure 19-2: Structures at Wilmington Intersection

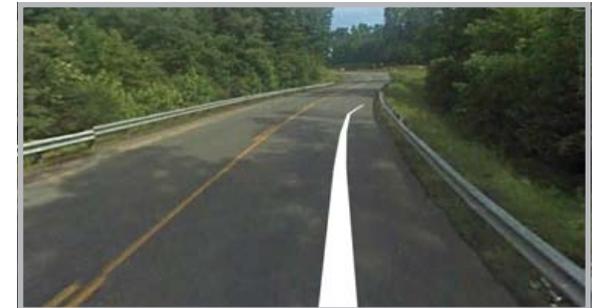
There are four (4) locations where the road section includes guardrails, which limits the ability of cyclists to maneuver away from the road in case of emergency. (Figure 19-3)

Figure 19-3: Guardrails on Courthouse Road

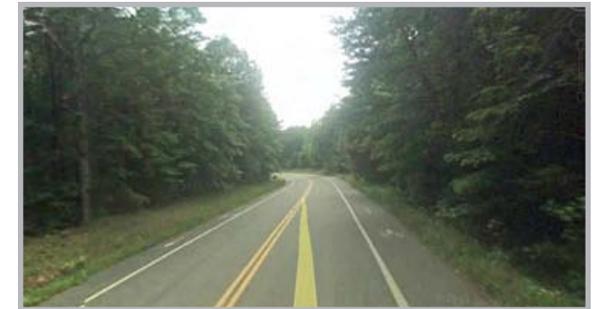
There are two (2) sections of Venable Road with bike lanes, both coinciding with culverts that span creeks (Phils Creek and Kent Branch). The bike lanes create additional space for cyclists, as there are guardrails on the road edges. The bike lanes are generally four (4) feet wide. (Figure 21-2)

Figure 20-2: Bike Lanes

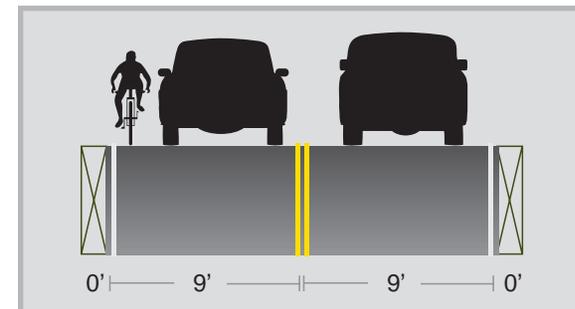
Figure 21-1: Typical Road Section

The RLRP identifies operational and geometric deficiencies on the southern segments of VA 605 and for Willis Profit Road. The plan recommends road reconstruction that includes full-width lanes and shoulders. These improvements are listed as long-term alternatives.

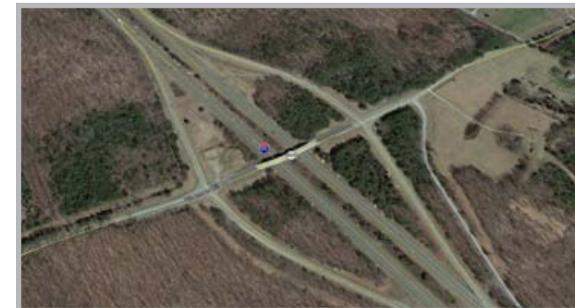
Figure 21-2: Interstate 64 Interchange

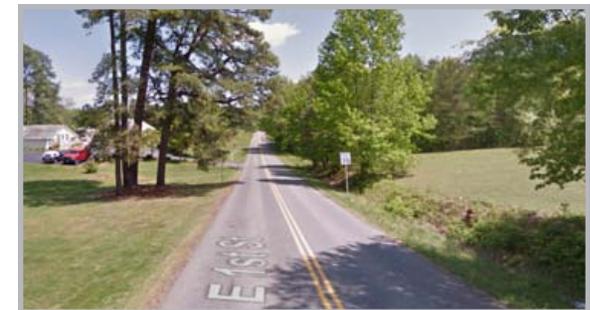
Figure 22-3: Typical Road Section for East 1st Street

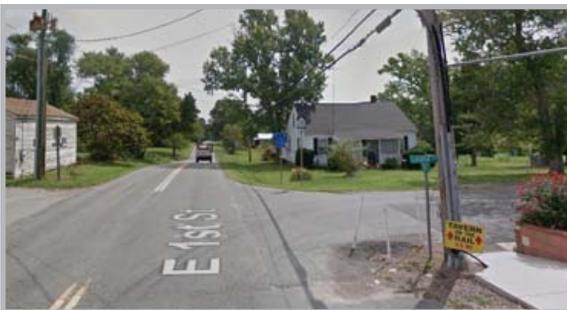
Figure 22-6: Sight-Lines from Louisa Avenue

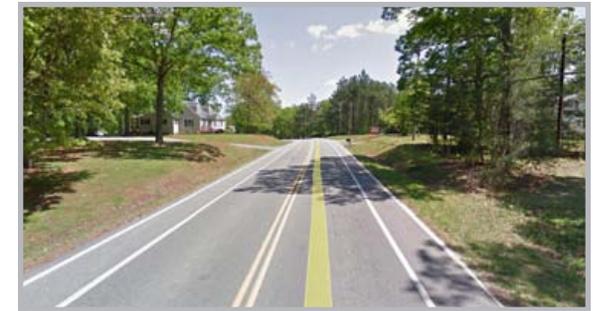
At the intersection with VA 703 (Spring Road) there are 4-foot bike lanes on the east- and westbound lanes. The bike lanes span approximately 720 feet, but then reduce back to a shared lane bike facility. (Figure 23-2)

Figure 23-2: Bike Lanes
