## Introduction

In 2012, the Thomas Jefferson Planning District Commission (TJPDC), also known as Region 10, started an initiative to study, promote and improve its portion of U.S. Bicycling Route 76 (BR 76). This report is the first step in this initiative, creating an inventory of existing conditions and highlighting recommendations for improving the safety and recreational value of the Route.

This report is a technical document, intended to highlight roadway deficiencies that diminish cycling safety along BR 76, in Region 10. As a technical document, the intended audience includes regional and state transportation planners, along with cycling advocates. This report is intended to document cycling compatibility, with a secondary goal of recording cycling amenities and tourist destinations.

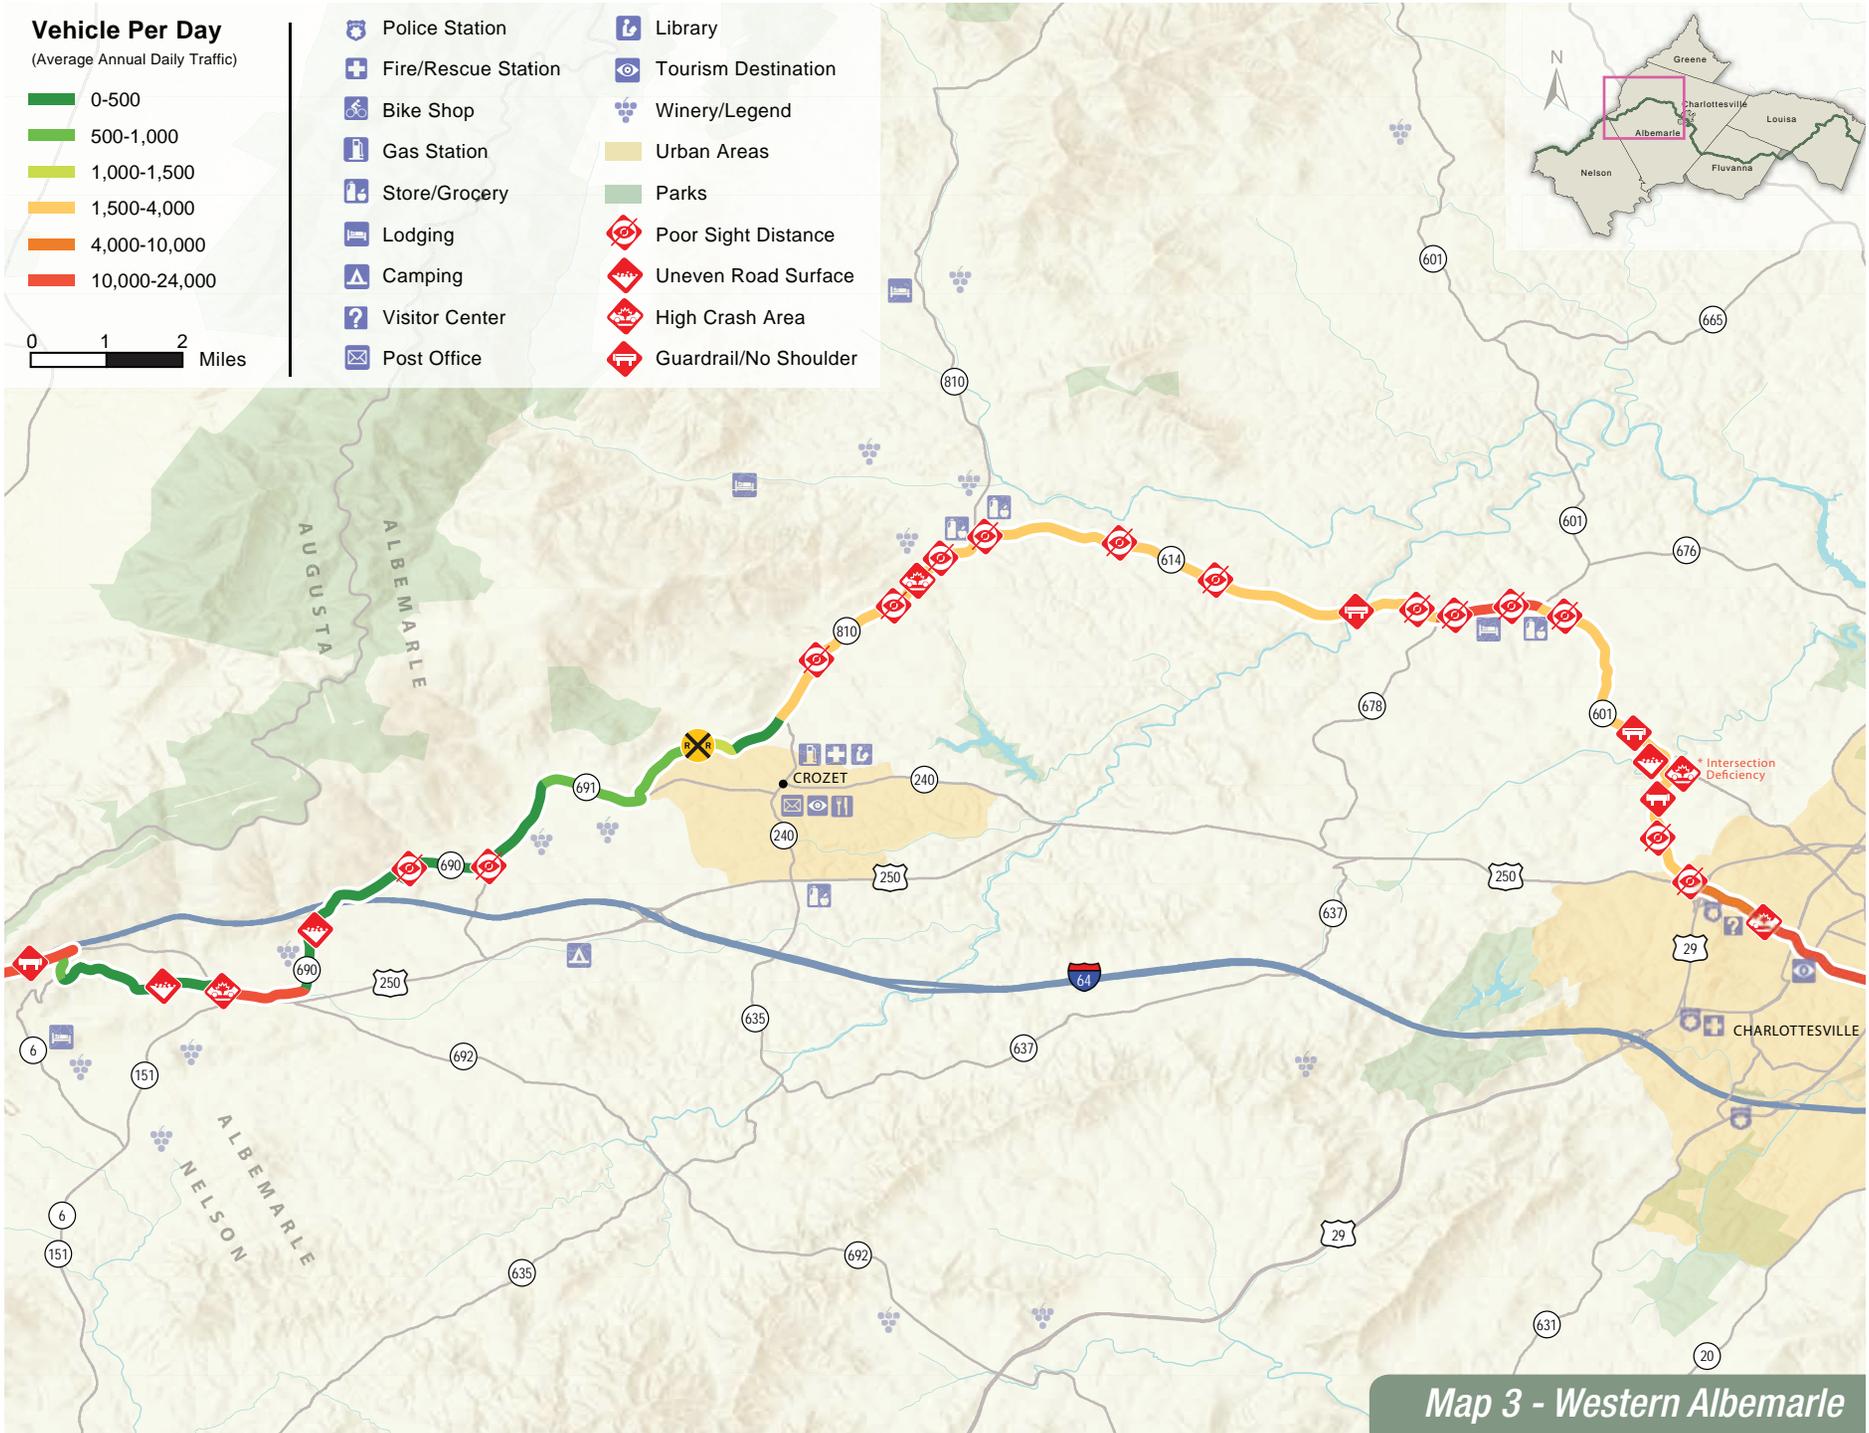
Map 3 - Western Albemarle

The western side of Albemarle County is home to some of the most valued scenic vistas on BR 76, along with several tourist destinations. In terms of safety, the over 26 miles of BR 76 also presents frequent cycling hazards. Map 3 illustrates the various safety deficiencies, involving sight-distances, uneven road surfaces, dangerous intersections and guardrails.

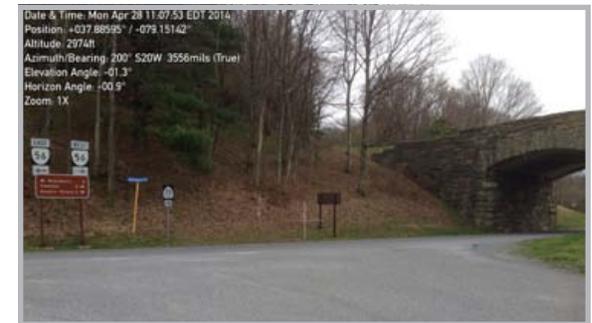
Figure 1-2: Crabtree Falls Intersection

This is a grade-separated rural interchange, marking the southwestern end of this corridor. With low traffic volumes and sufficient sight distances, there are no immediate deficiencies apparent in this area. (Figure 1-2)

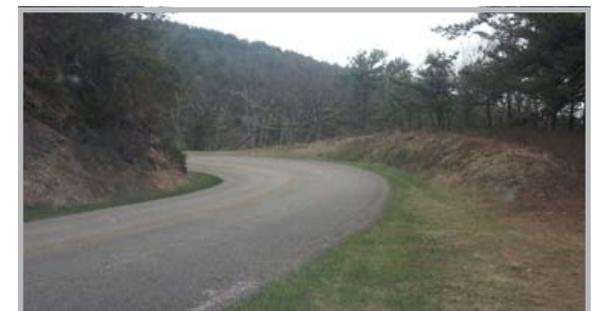
Figure 1-4: Problematic Sight-Lines

There are select curves with poor horizontal sight distance. These hazards are more problematic to cyclists when motorists have blocked sight-lines of the uphill lane. As cyclists climb, they travel at lower speeds and typically require additional room to maneuver. (Figure 1-4)

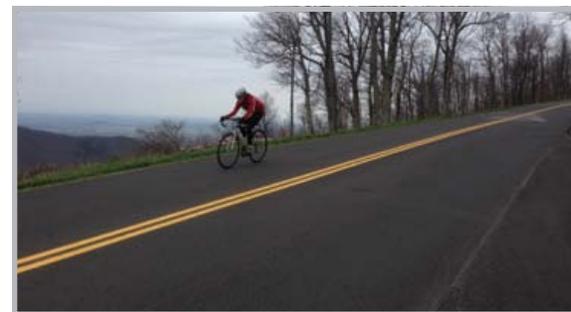
Figure 1-6: Scenic Resources

Nearly the entire Parkway provides access to scenic vistas of the Shenandoah Valley or Rockfish Valley. There are also hiking areas like Humpback Rock that provide scenic visits. (Figure 1-6)

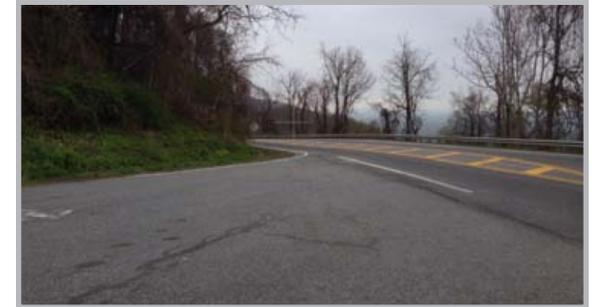
Figure 2-2: Sight Distance

The main sight distance deficiencies are located at the intersections with US 48 and US 6. Aside from those areas, this corridor allows for adequate sight-lines. (Figure 2-2)

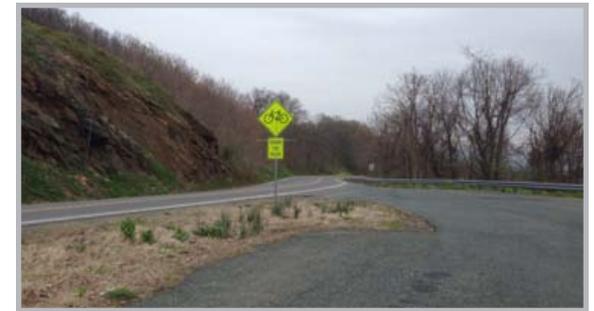
Figure 2-4: US 250 Overlook

US 250 is designated as a Virginia Byway, because of its views and rural character. On the eastbound lane, there is an overlook that provides views of the Rockfish Valley. (Figure 2-4)

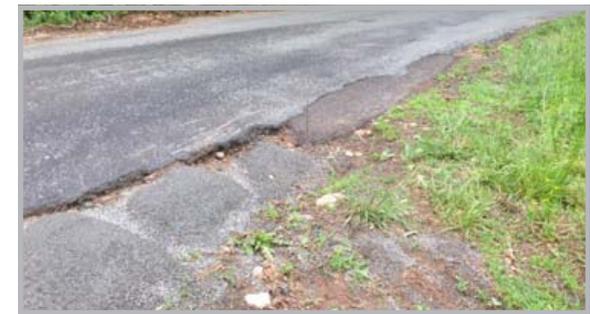
Figure 3-4: Example of Poor Surface Conditions

On VA 750, the pavement surface is in fair condition, but there are locations where the asphalt is cracked or broken. Additional, there are several areas where ditches or embankments are directly adjacent to the roadway. This gives no room for cyclists to maneuver or bail from the roadway. (Figure 3-4)

The TJPDC should conduct a more in-depth inventory of surface conditions on VA 750 and work with VDOT to repair damaged pavement.
